Maryland Historical Trust

Historic Properties Form

Inventory No. M: 20/32

historic Irvington Farm

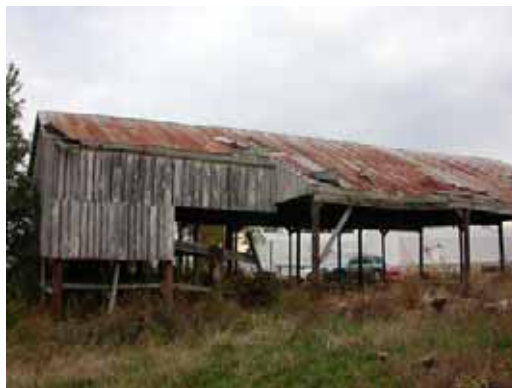
South Façade: The south façade shows the two distinct parts of the structure, with the east portion being the hay storage shed through which the wagons would pass to collect the hay. The west portion is the attached drying loft, with vertical siding to protect the machinery.

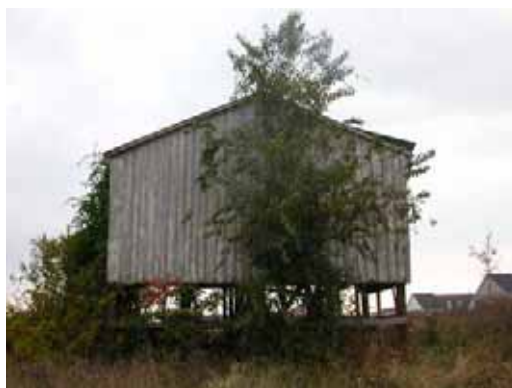
West (rear) Façade: The west-facing gable end has no windows or vents. It is clad with vertical wood siding. The siding starts approximately three feet off the ground, providing additional ventilation and air circulation.

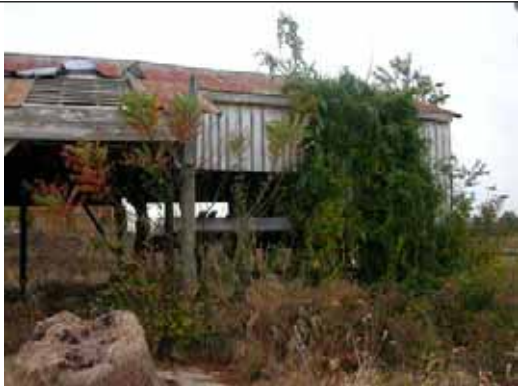
North Façade: The north façade is similar to the south façade, with its five wagon bays, and two additional bays for the hay loft. Wagons were prevented from entering in the bay closest to the hay drying loft with a board nailed between posts (in the second bay from the west end), as the vertical board siding only extends a little lower than the ceiling level.

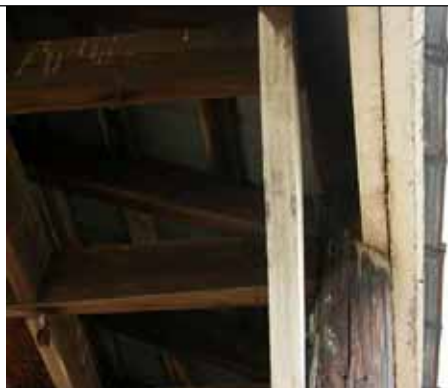
V-notches where beams meet rafters

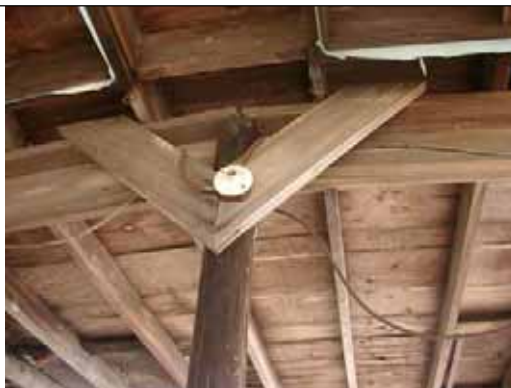
V-braces

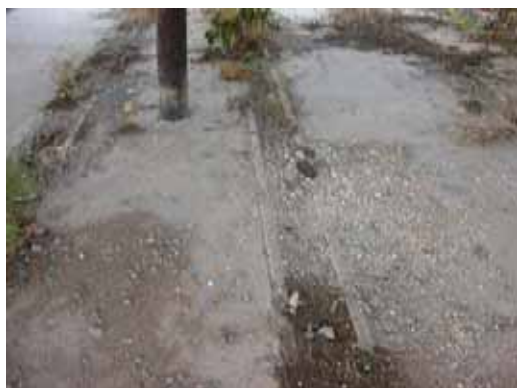
Wagon wheel channels

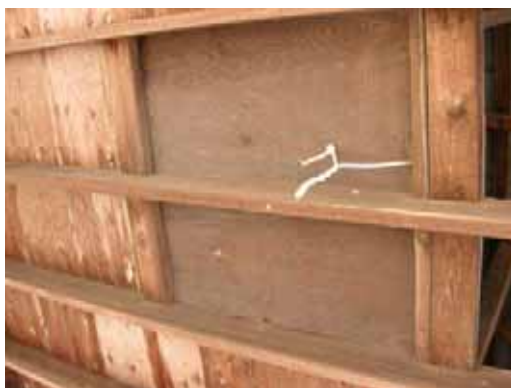
Hay Hatches

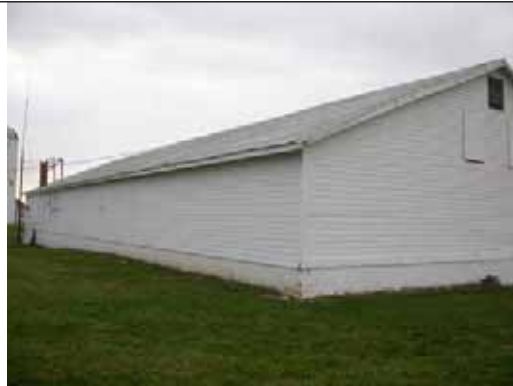
North Façade: The north façade has five windows towards the south end. Three of these light a room within the main portion of the barn, while the other two light the office/kitchen room. An internal brick chimney is located between these two internal spaces.

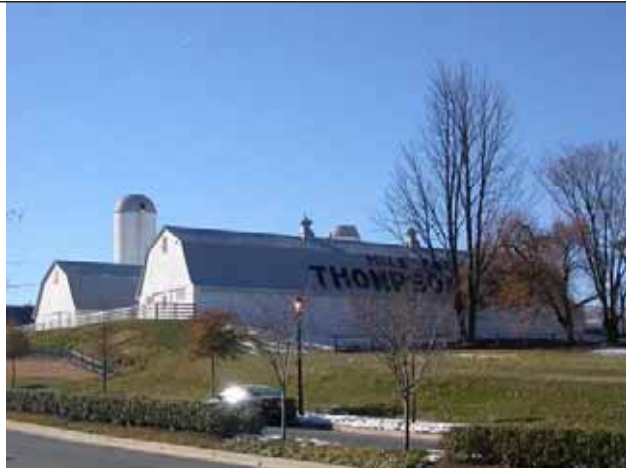
East Façade: The east façade of the milking barn is parallel to Frederick Road. The gambrel roof, with kicked eaves, sports a painted sign "Milk for Thomson's Dairy", centered on the original concrete block building. A later plain-faced concrete block addition was added to the south end, at some time after the sign was painted. The addition matches the original in roof and wall planes. There are three ventilators at the ridge of the original structure. Hopper windows are evenly spaced along the entire length of the original façade; while smaller windows were added under the eaves on the new addition. All of the windows are currently boarded up.

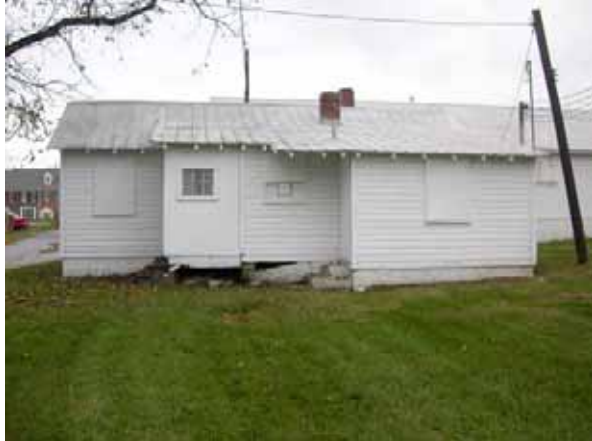
North: The main entrance is on the north façade, set perpendicular to the farm lane. A small porch enclosure, formed by a thin wood wall, which contains a window for additional light, provides weather protection at the entrance. This window sash appears to be reused from another location. A front door is wood paneled, with a single fixed glass pane for the top half. There is also a screen door.

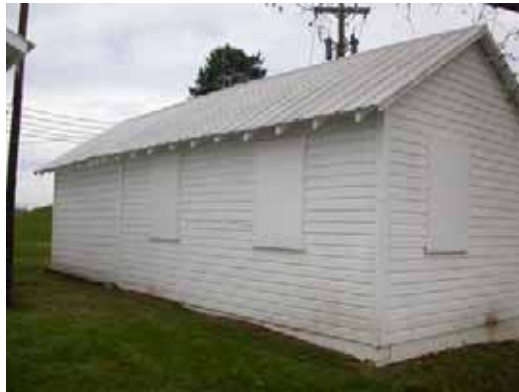
South: The south façade is in a single plane, with a continuous roofline, although it consists of the original building and an addition at the west end. The wider siding is evident on the left bay and slightly narrower on the right. A vertical trim board separates the two. Two identical 6/6 windows are in the original portion. A concrete block foundation supports the right side and concrete piers support the left addition.

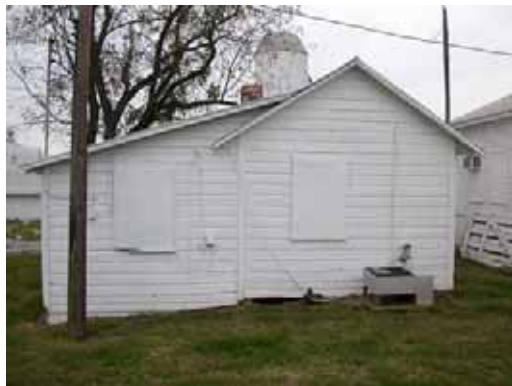
West: The dual roof lines reflect the additions added to this small cottage, to accommodate residents. The gable roof reflects the massing of the original cottage, while the shed roof provided additional living space. There is a single window in each portion.

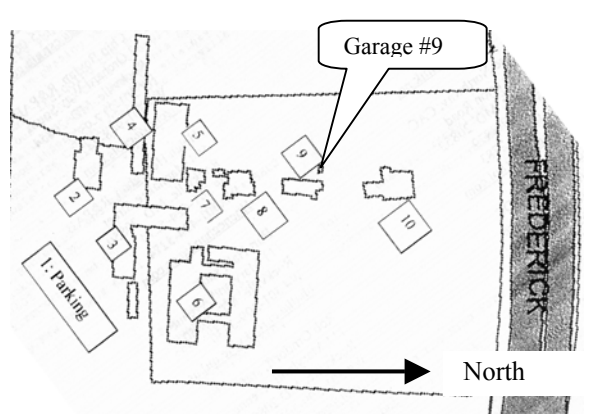
General: It sits on a generally flat site, with a grassy incline rising on the west side (and draining to the building), and an asphalt parking area along the east side. There are some large overgrown shrubs in the immediate vicinity. A deteriorated outdoor brick hearth is attached to the chimney that sits in the corner between the garage and the one-story addition on the north façade.

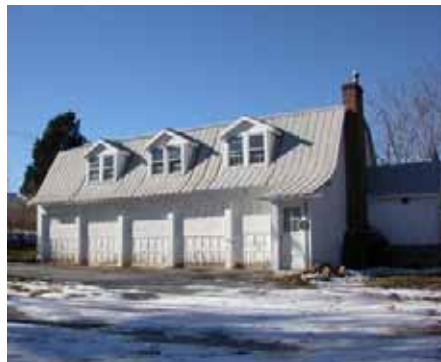
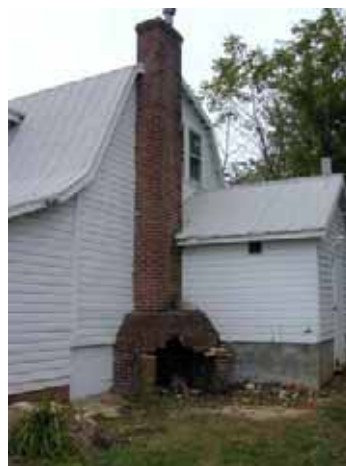
The small one-story side-gable building attached on the north façade is accessible only from its doorway on the north façade. The wood German siding is painted white, and there is a small opening (vent) high on the wall just under the eaves. The foundation is exposed to a height of approximately two feet, and is parged with concrete. An outdoor brick fireplace was built to use the exterior brick chimney as its flue. The fireplace is deteriorated. This small addition is also roofed with painted standing seam metal.
